CITY OF CORNWALL
CORNWALL ARTS + CULTURE CENTRE FEASIBILITY STUDY
PHASE II - FIT TEST
159 PITT STREET, CORNWALL, ONTARIO

FINAL REPORT - 2018.05.04

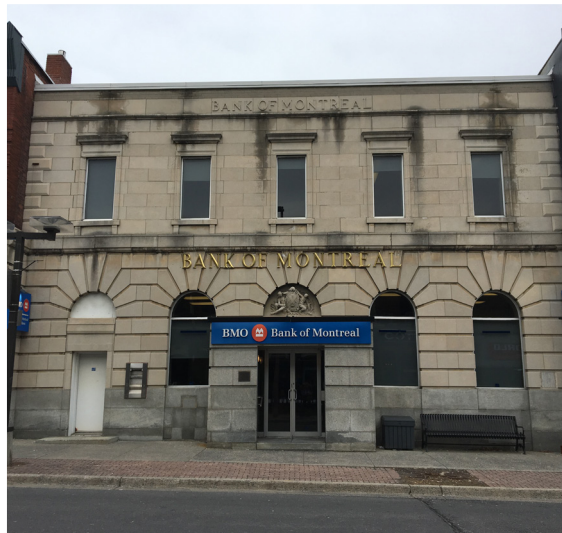
Front Elevation of 159 Pitt Street. Photo by +VG Architects, 2018.

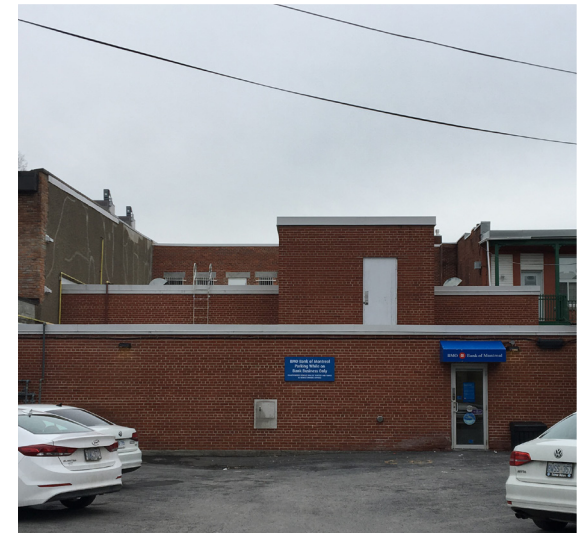
Rear Elevation of 159 Pitt Street. Photo by +VG Architects, 2018.

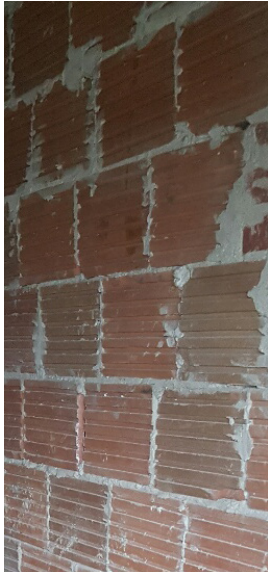
Interior clay tile brick located in the third segment/addition of the existing bldg (roof tower).

The third segment is a single story addition about 22 feet in length with no basement. The roof framing consists of ribbed precast concrete slab supported on load bearing exterior masonry walls.

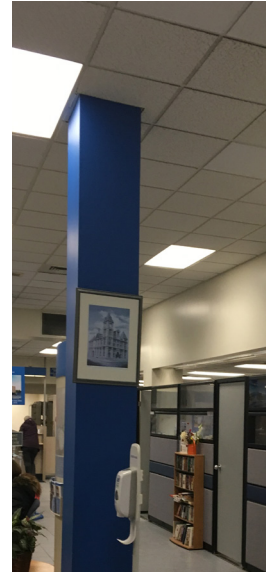
Interior column within central area of bank building, clad with drywall or plaster and painted.

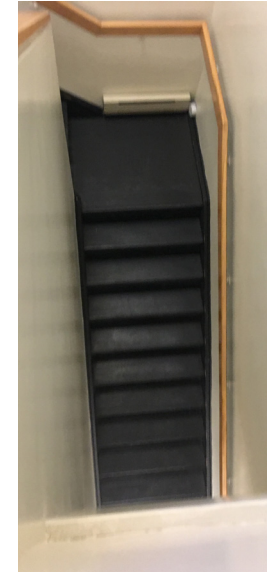
Existing stairwell located at the northwest corner of the building to access the second level (front section of the building only).

There are currently three exits serving the building, one located in the centre of the front facade to Pitt Street (west/southwest), one from the stairwell at the west/southwest corner of the building, and one at the east/northeast corner of the building to access the rear parking lot and laneway.

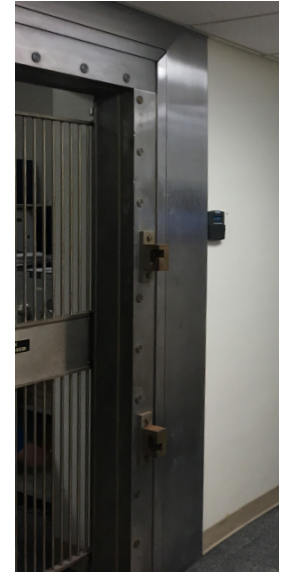
View of existing vault at the rear of the building. Noted in the drawings in section 4, to be demolished if desired.

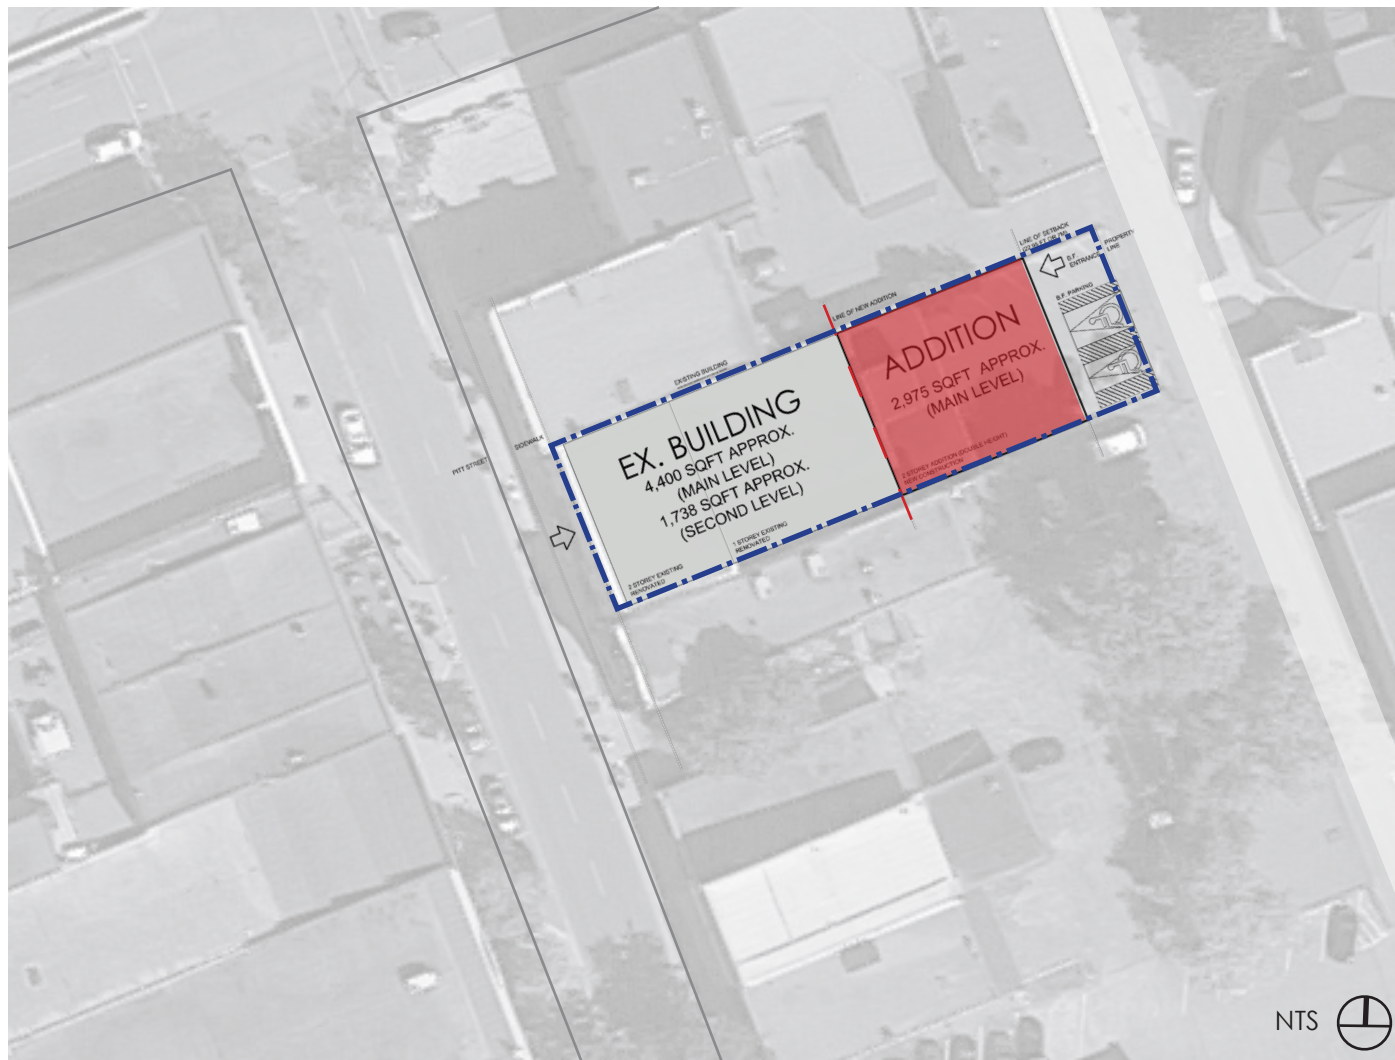
SCENARIO A - Site Plan Existing Masonry Building

(Renovation)
1 Storey - 4,400 sq ft
2 Storey - 1,738 sq ft

As an adaptive re-use project involving renovation and an addition, the design and construction of the facility in the Scenario A proposed utilizes some existing spaces within the existing building on the Main Level and Second Level, while a modest addition accommodates the new Black Box Theatre and some Back of House spaces. This option would meet the space requirements for the small Arts and Culture Centre in the downtown core while balancing the feasibility and costs associated with a major renovation project with minimal demolition to the existing building. These requirements include a flexible, multi-use Black Box Theatre space that could accommodate approximately 150 - 200 people, a "Back of House" area for Green Rooms (performance preparation) and storage, and a "Front of House" area that includes a reception space and lounge, box office, and gallery/rear entrance hall. The second story is programmed for green room studios or offices, and as such an elevator would be required to access this floor.

The first scenario considers the possibility of implementing the proposed Arts and Culture Centre in a way that would minimize the impact on the existing structural system, and reduce the need to remove or alter the majority of the existing structure. The proposed option suggests demolition of the third and smallest addition to the building, and locating the addition here to accommodate a black box theatre for approximately 150-200 people. A structural assessment of the existing building concludes that scenario A is the recommended option, as it requires the least amount of new construction and costs associated with new construction. Further, it requires the least amount of demolition, and the structural requirements to brace the existing building and address snow loads are minimal. With this option, the performance level of the building is not reduced by the demolition of the smaller existing addition, and so the concerns around triggering seismic investigations are also reduced.
